Enclosure Pre-inspection Report

Client: Justin Merritt Inflector Environmental Services 196 Hobsons Lake Drive Halifax, Nova Scotia B3S 0G4	Project #: 30138 Location: Teachers Room/Room 9 Enclosure - Bicentennial Shift: N/A Issue Date: December 1, 2022 Report #: 01
--	--

On December 1st, 2022, Alisha Glogowski of ALL-TECH Environmental Services Limited (ALL-TECH) completed a pre-inspection on the enclosure constructed within the Teacher's Room/Room 9 at Bicentennial School located at 85 Victoria Road in Dartmouth, Nova Scotia.

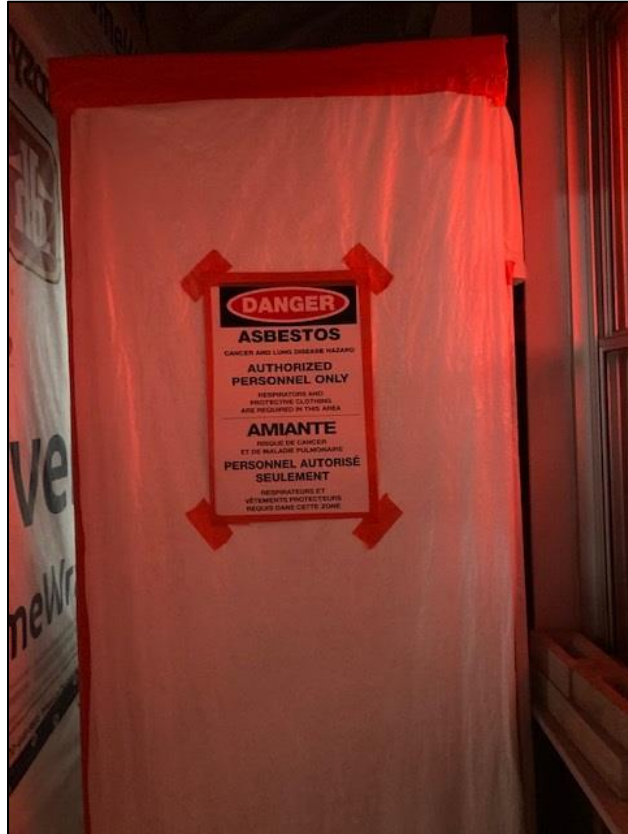
Figure 1.0: Appropriate signage to all entrances to the enclosure.

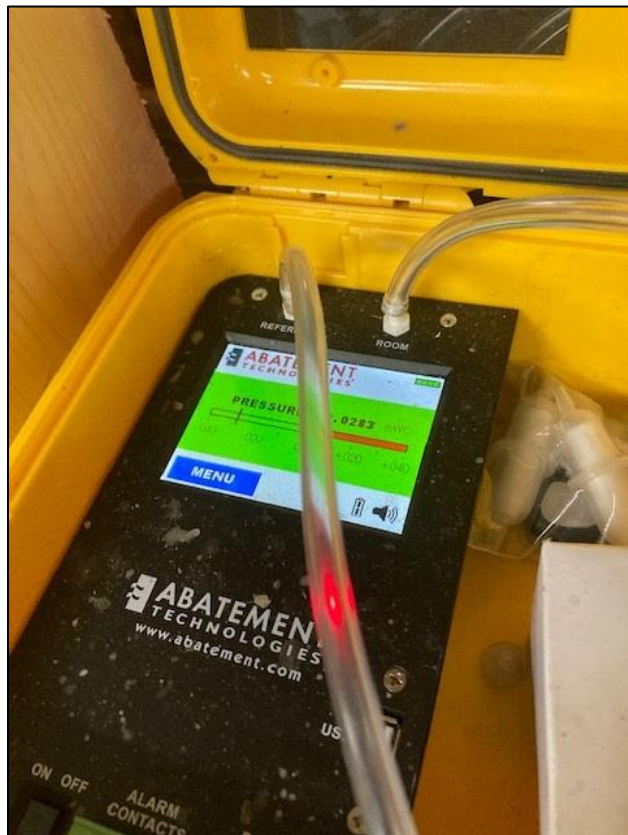
- The enclosure has sufficient negative air pressure (-0.028" WC) which is being monitored using a OMNIGUARD Differential Pressure Recorder, alarm activated device. The OMNIGARUD is located within Room 9.
- Any access point/doors that are not being used, are sealed off by pre-existing doors which are covered and openings are sealed using fibre reinforced tape and minimum 6mil rip-proof fire-resistant polyethylene sheeting.

Figure 2.0: Adequate negative air pressure.
